## The 2014 Cadillac ELR

## TECHLINK

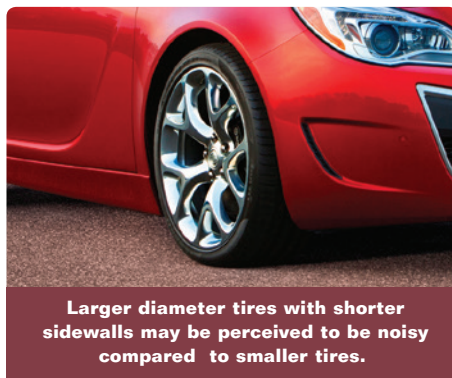
Larger diameter tires with shorter sidewalls may be perceived to be noisy compared to smaller tires.

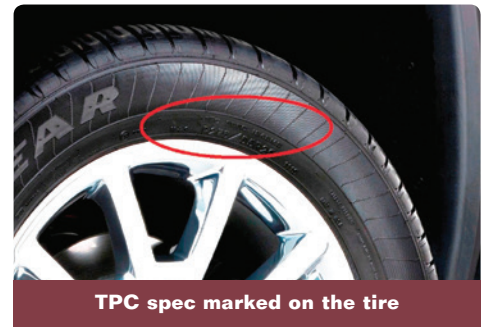
TPC spec marked on the tire

A replacement tire should have the same TPC specification number as the original equipment tire. This will ensure the same size, the same load range, and the same construction as those originally installed on the vehicle.

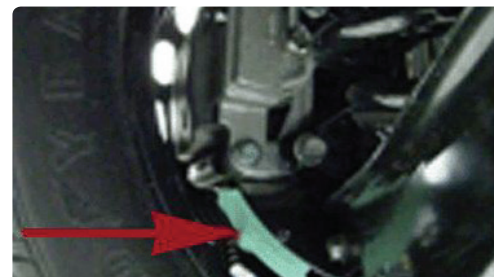
**Remove the brake rotor protection covers during PDI.**

The factory-installed rear disc brake rotor protection covers must be removed during the PDI. With the vehicle on a hoist, rotate the wheel while at the same time pulling the torn end of the cover away from the disc brake rotor and wheel. Ensure that all material is removed and repeat for the other side.

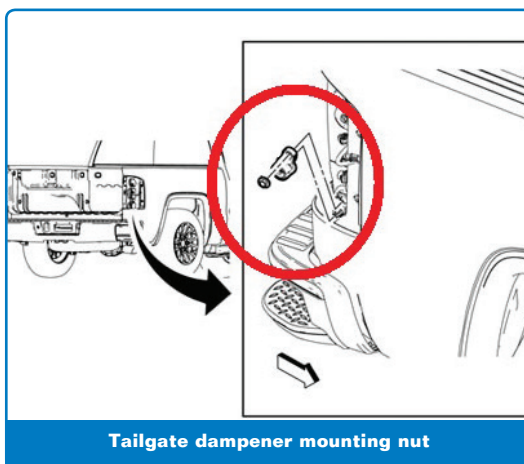
On some 2014 Silverado 1500 and Sierra 1500 models equipped with the EZ Lift and Lower Tailgate (RPO PPA), a pop/snap/click-type noise may be heard when the tailgate is opened. It may sound like the noise is coming from the right-side hinge area. The noise may be caused by the tailgate dampener mounting nut not being torqued properly.

To correct this condition, inspect the tailgate dampener mounting nut for proper torque. It should be torqued to 25Nm (18lbft) +/- 3 Nm (2 lb ft).
